UNITED STATES ENVIRONMENTAL PROTECTION AGENCY
REGION 10
IDAHO OPERATIONS OFFICE
1435 N. Orchard St.
Boise, Idaho 83706

MEMORANDUM

SUBJECT: Sackett Site Inspection Report

Date: June 1, 2007

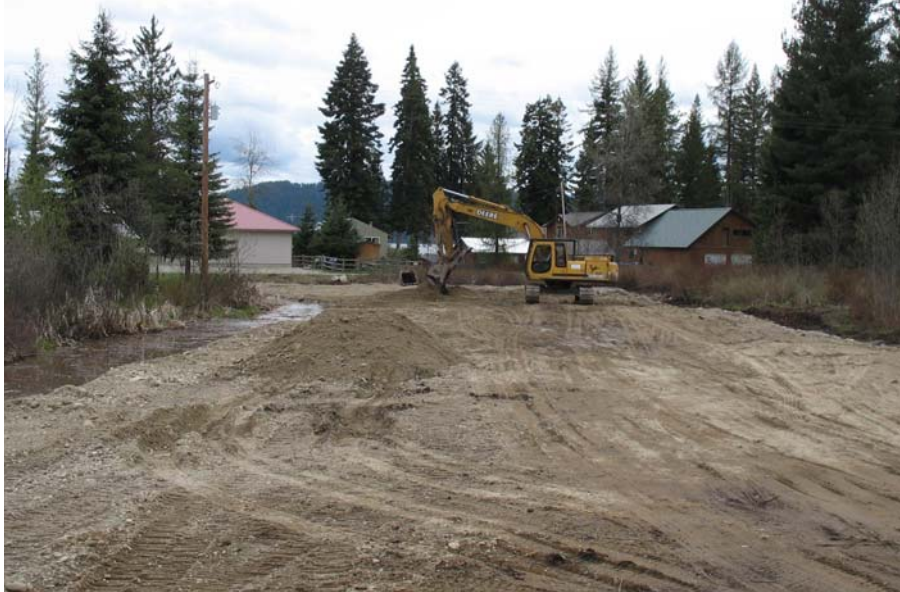
1) Excavator filling excavated wetland site, Mike and Chantell Sackett's lot.

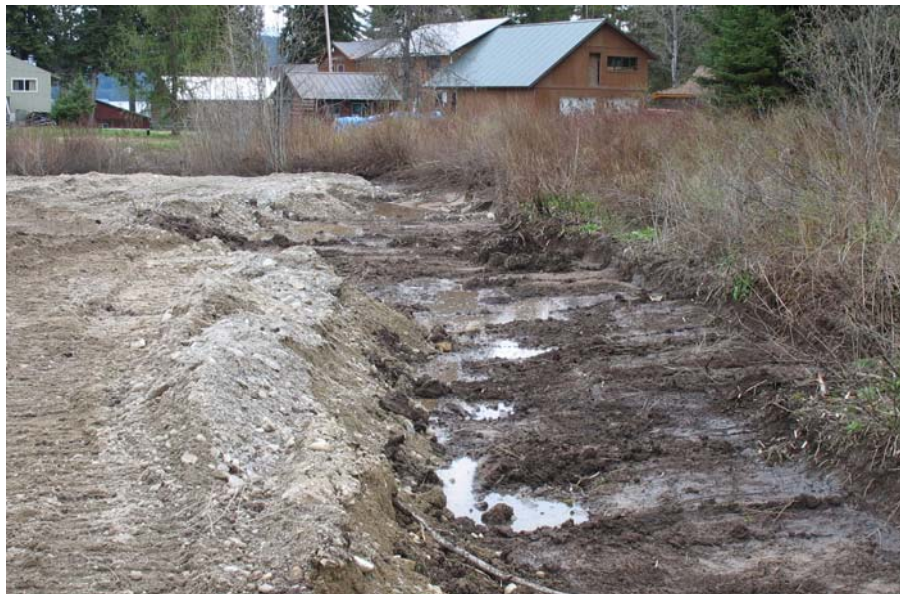
John paced off the area that was filled, and took some photographs of the site. The area filled was approximately 300 feet by 100 feet. Chris explained he had been told to fill the whole lot. Along both the east and west property boundaries, strips of excavated ground remained to be filled (photos 2, 3 and 7). These strips of excavated ground revealed wetland soils (photos 2 and 3). The vegetation on neighboring properties and on the south end of the Sackett lot consisted of the wetland species, including red osier dogwood (photo 15) and alder.

2) West side of lot showing a strip of excavated ground on the right abutting the neighboring property of intact wetlands; fill shown on the left.

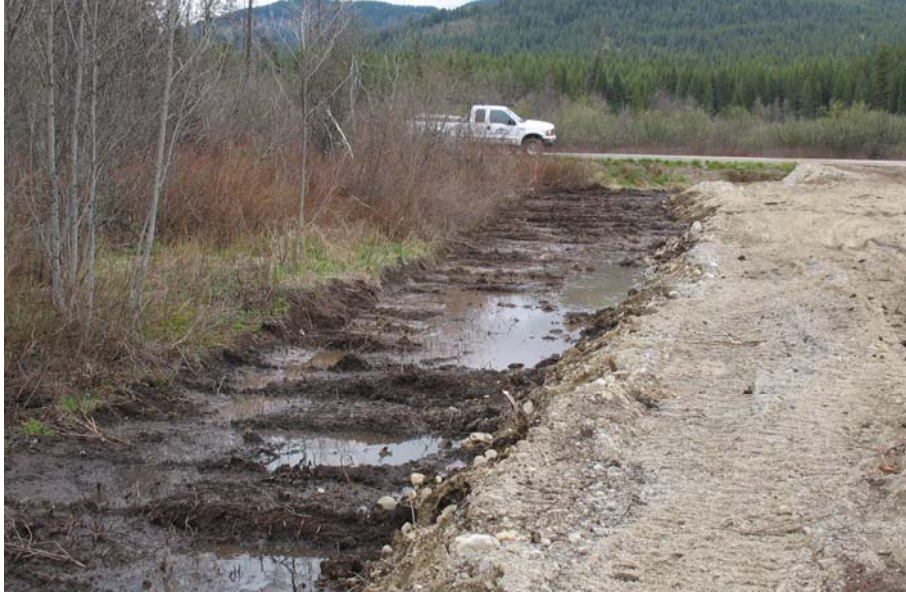
3) Same excavated area in photo 2, photographed from the south with the neighboring property of intact wetlands on the left, fill on the right.

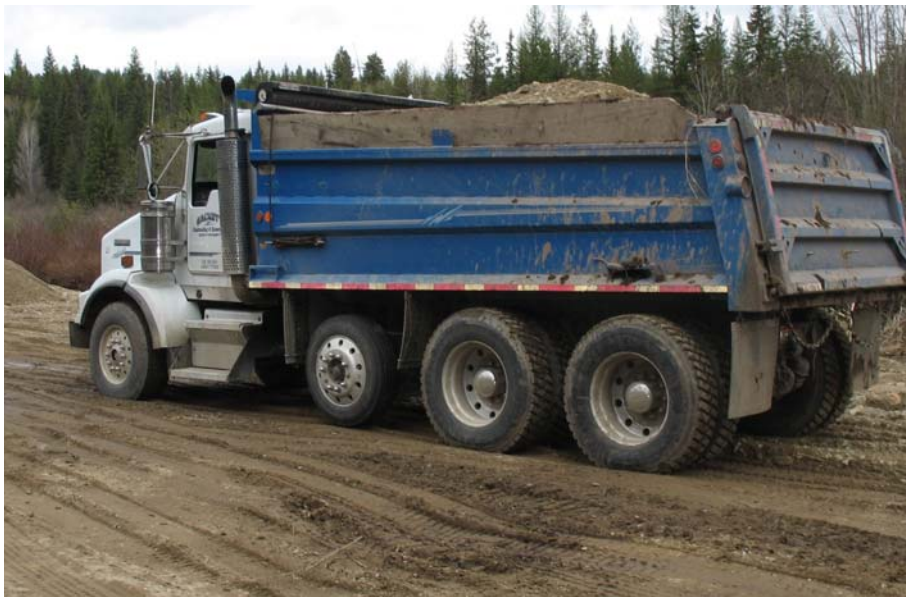
4) Dump truck loaded with fill.

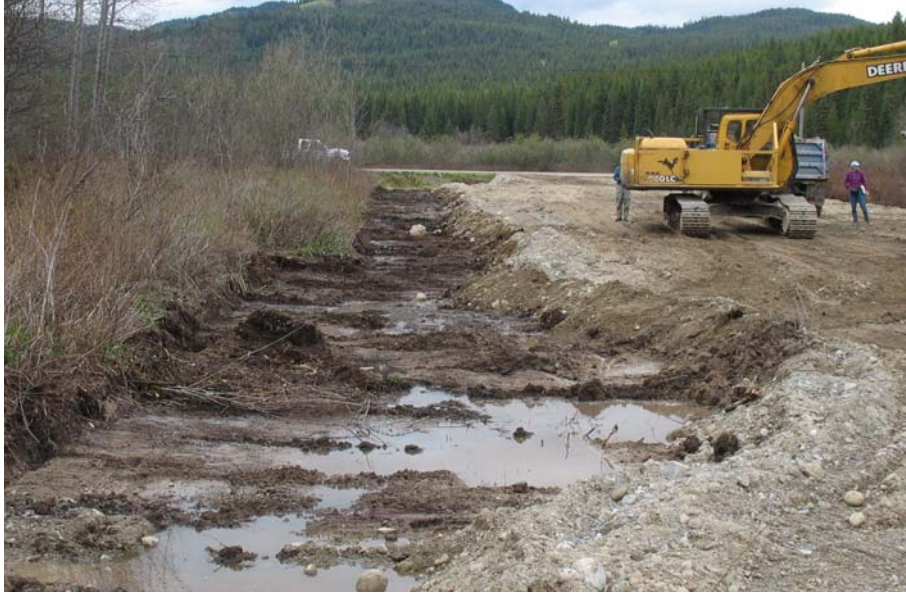
5) Another view of the west side of lot.

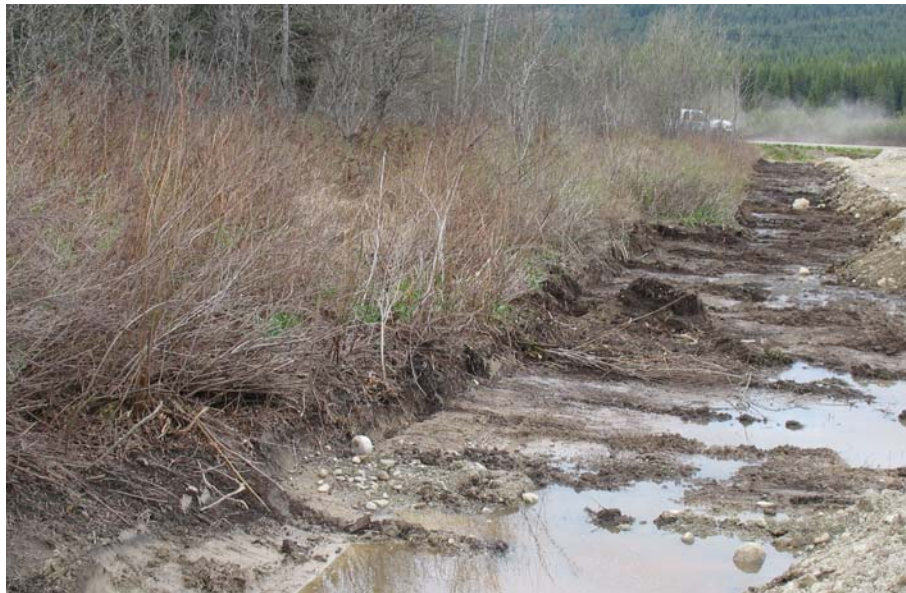
6) Another view of the west side of the lot.

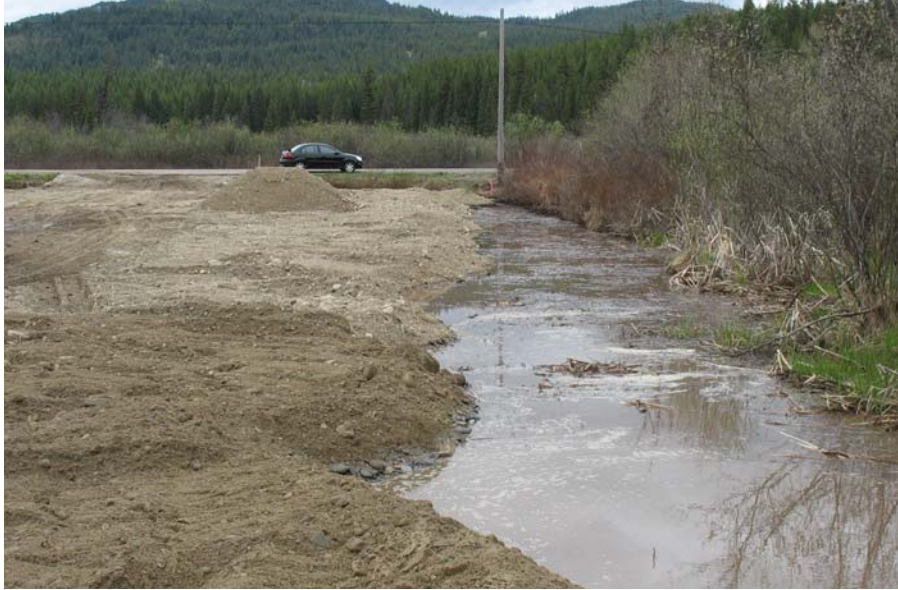
7) East side of the lot showing a strip of excavated ground that was being filled when we arrived.

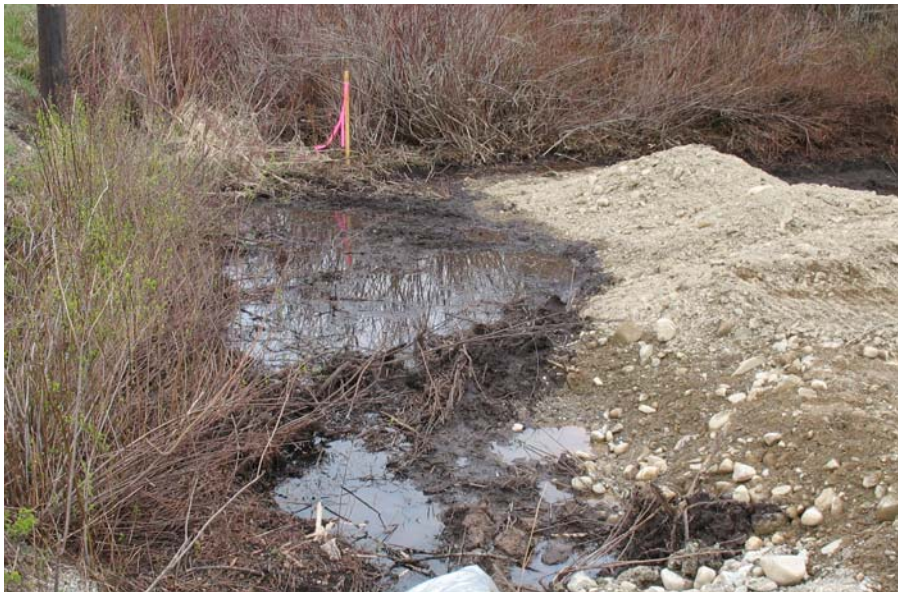
8) Culvert placed at entrance to the lot.

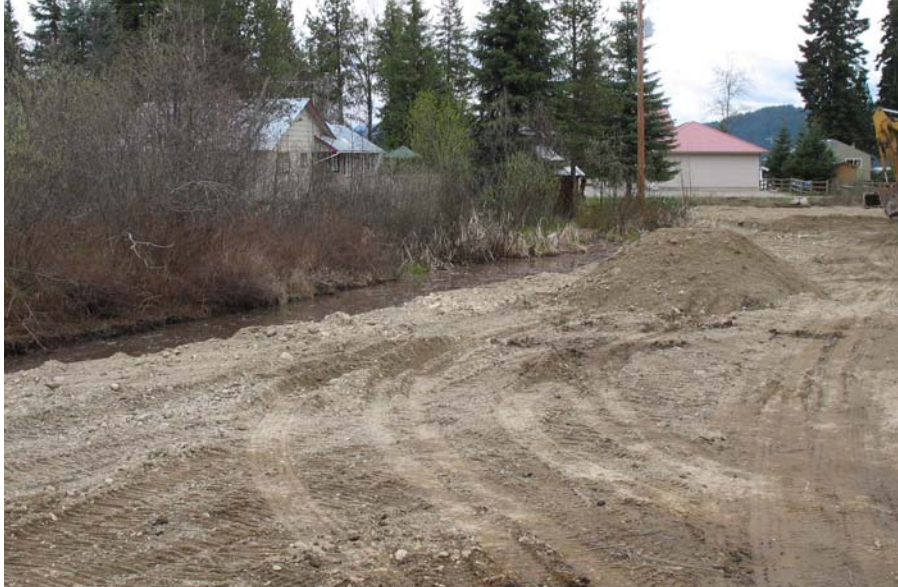
Prior to leaving the site at about 3:30pm, a neighbor spoke with John Olson, explaining that occasionally water comes over the road from the wetland to the north, flowing into the filled wetland. The neighbors to the east of the Sackett's lot told us the area filled had looked exactly like their backyard (photos 9 and 10).

9) East side of lot showing the excavated strip that was being filled when we arrived, and backyard of the neighbors to the east.

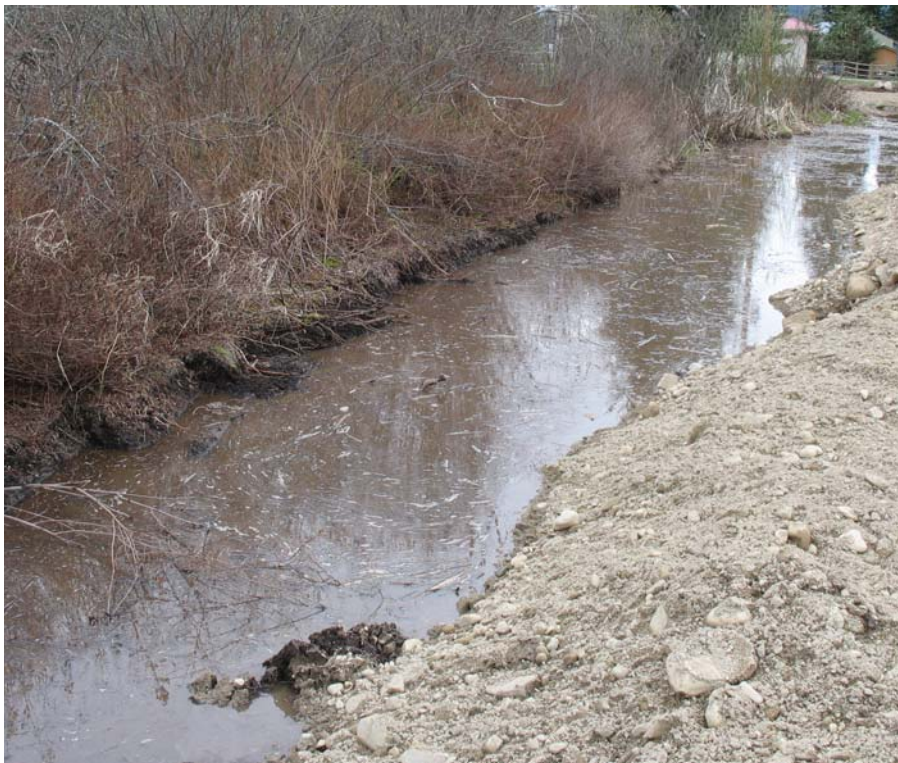
10) Another view of the east side of lot and backyard of the neighbors to the east.

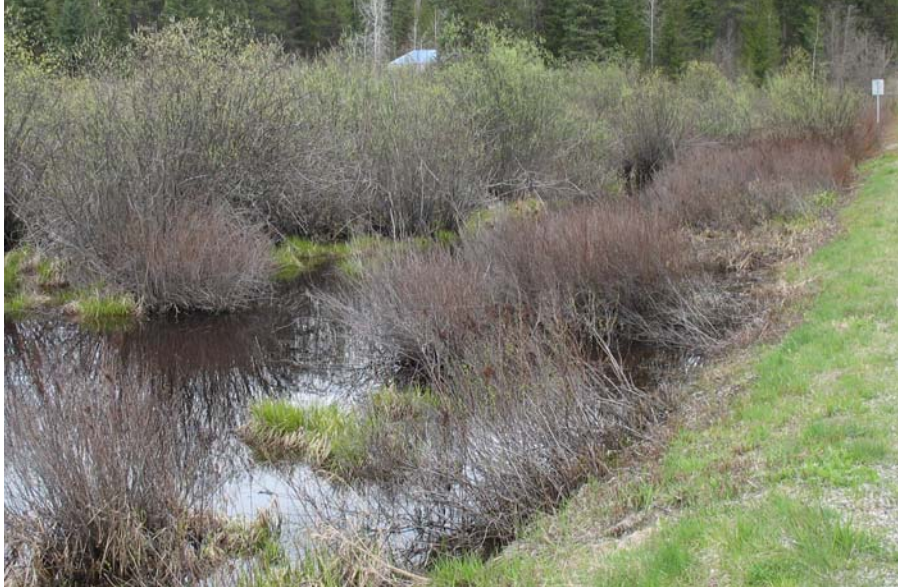
11) Wetlands on the north side of Kalispell Bay Road, looking east.

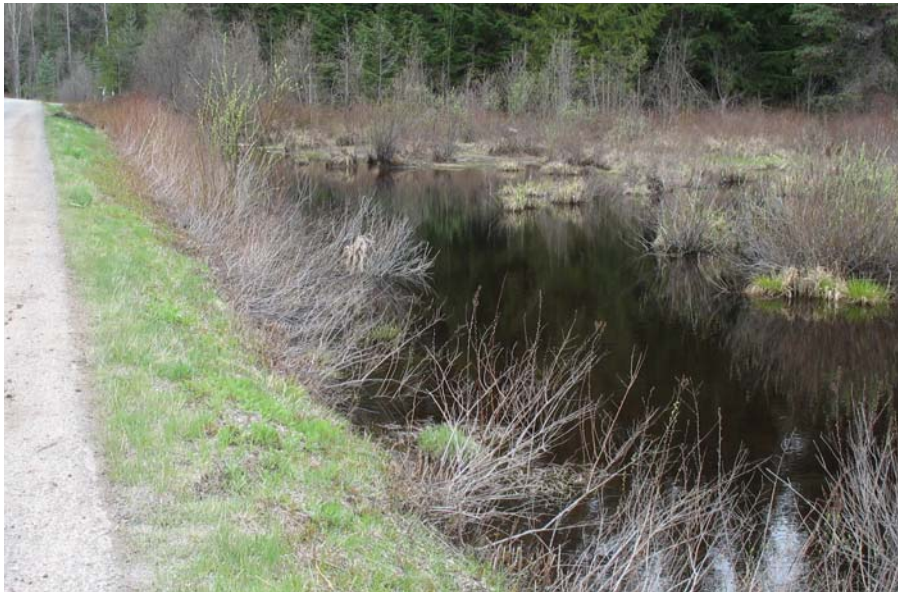
We returned to the site to look for culverts connecting the wetland to either the wetland on the north side of Kalispell Bay Road or connecting the wetland to ditches or another waterway draining into Priest Lake to the south. We did not see culverts under either Kalispell Bay Road or Old Snyder Road which is between the wetland and Priest Lake. The wetland to the north of Kalispell Bay Road (photos 12 and 13) drains via what appeared to be a roadside ditch to Kalispell Creek which flows into Priest Lake.

12) Wetlands on the north side of Kalispell Bay Road looking east.

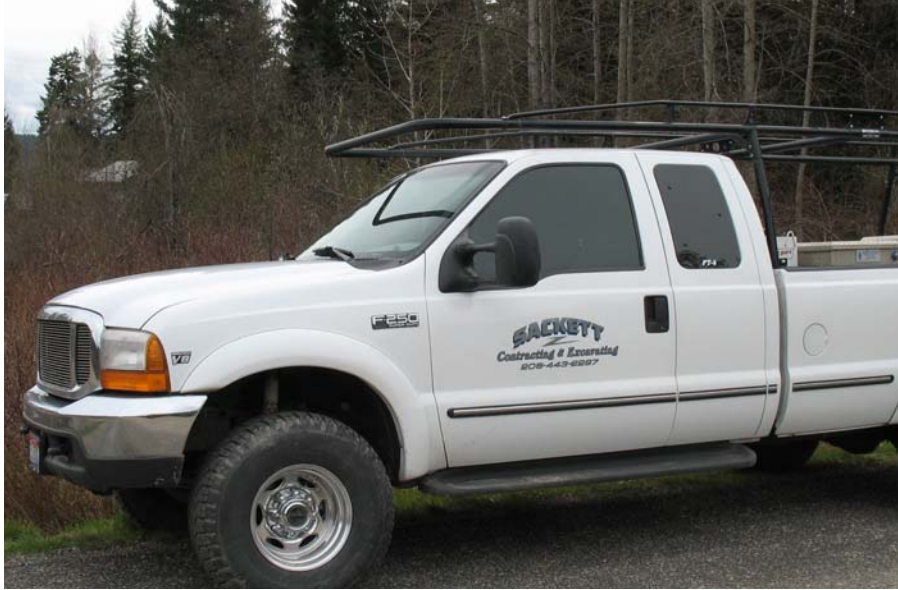
13) Sackett Contracting and Excavating company truck.

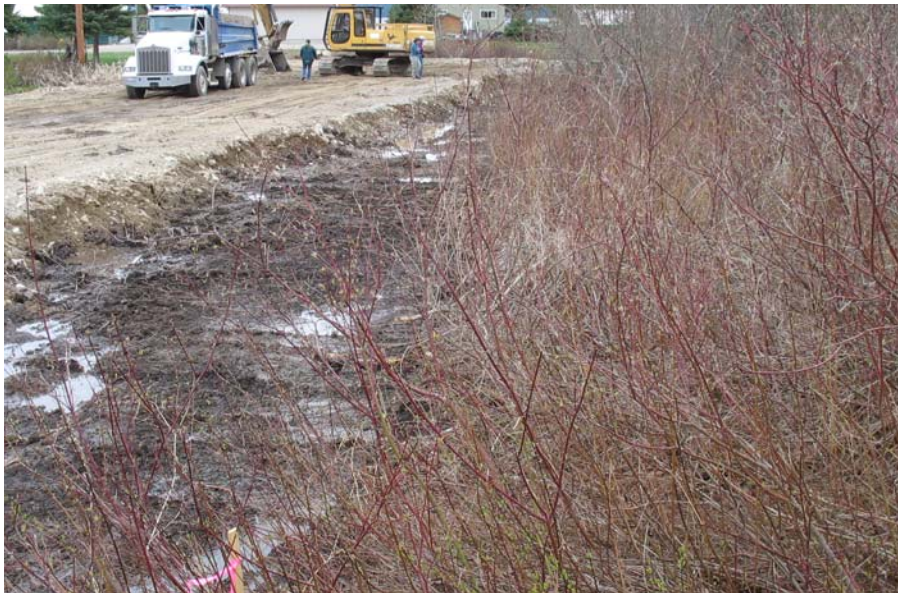
14) Red-twigged vegetation in the foreground is red osier dogwood.
The stake delineates the northwest lot corner.

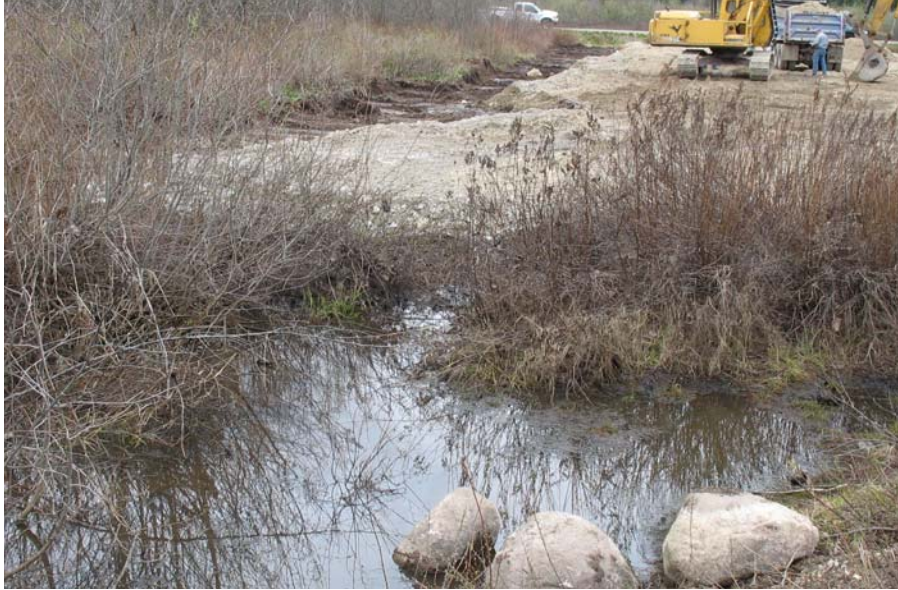
15) South end of the Sacketts' lot.
