**Re: Sudnikovich Property, Nordman Area, Bonner Co, ID
Sackett Wetland Issues**

**Re: Sudnikovich Property, Nordman area, Bonner County, ID
Assessment of Wetland Potential at "dumpsite"**

encls: Figure 1 - Vicinity Map
Figure 2 - Aerial Photograph and Overview Location Map
Figure 3 - Aerial Photograph, Fill, Data Plot, and Photograph Location Map
Photograph Sheets (2)
Data Forms (3)

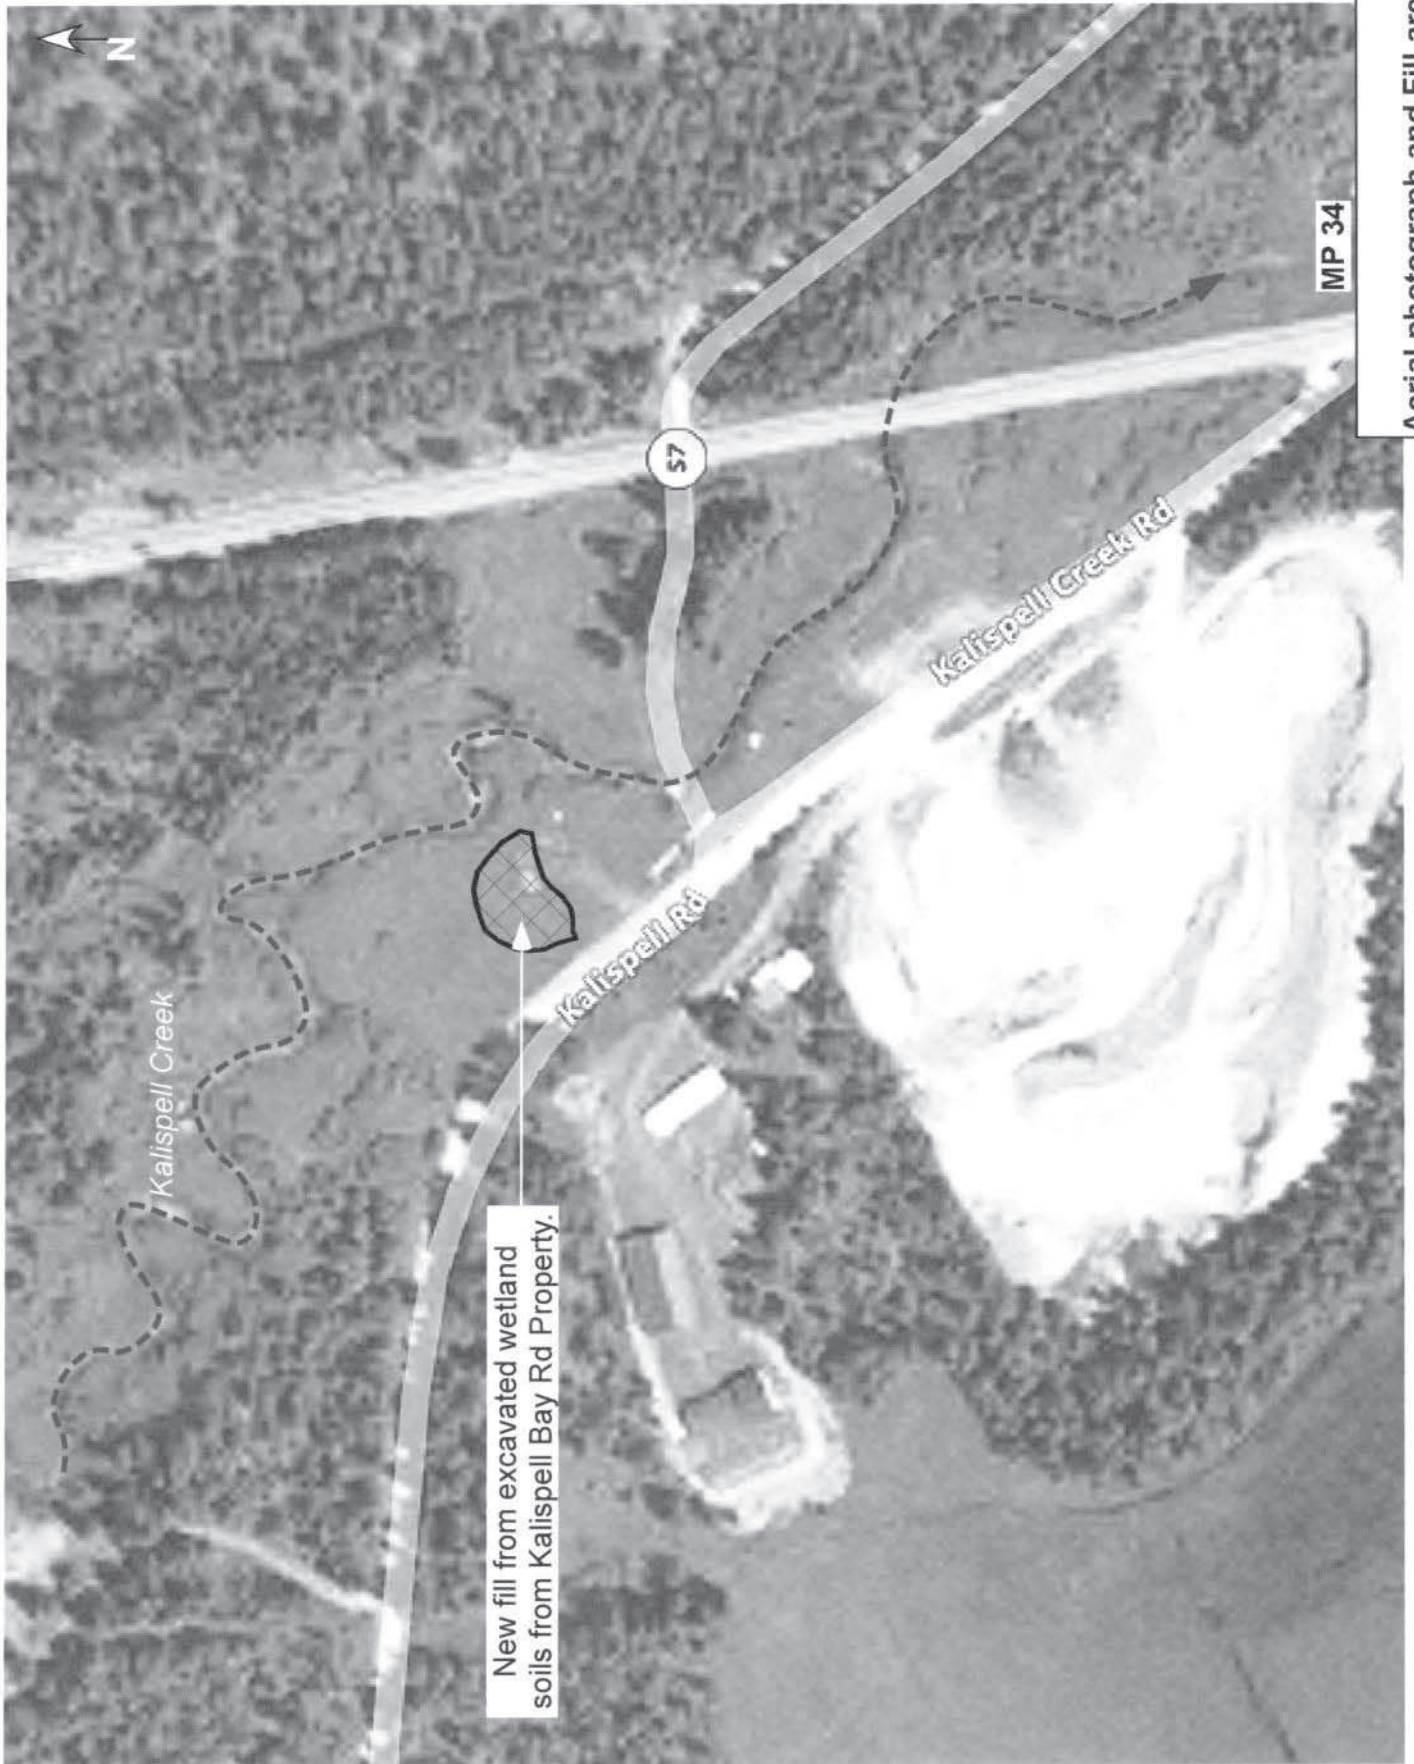
Figure 2.
Aerial photograph and Fill area Overview
Sudnikovich Property
Sackett "dumpsite"

The area surrounding the recently placed material consists of a benched area south of, and topographically above the Kalispell Creek channel. Evidently there was some fill placed (and possibly formed a portion of the bench) in the 1960's by the Idaho Transportation Department during re-alignment of State Route 57 at the junction of Kalispell Creek Road and SR 57. Thus vegetatively, the benched area would be considered "disturbed". There is a roadside ditch along the north side of Kalispell Creek Road from a short entrance road into the property, which shunts the Hager Lake watershed runoff to the west where it connects with another ditch running roughly north to discharge into Kalispell Creek (see attached figures).

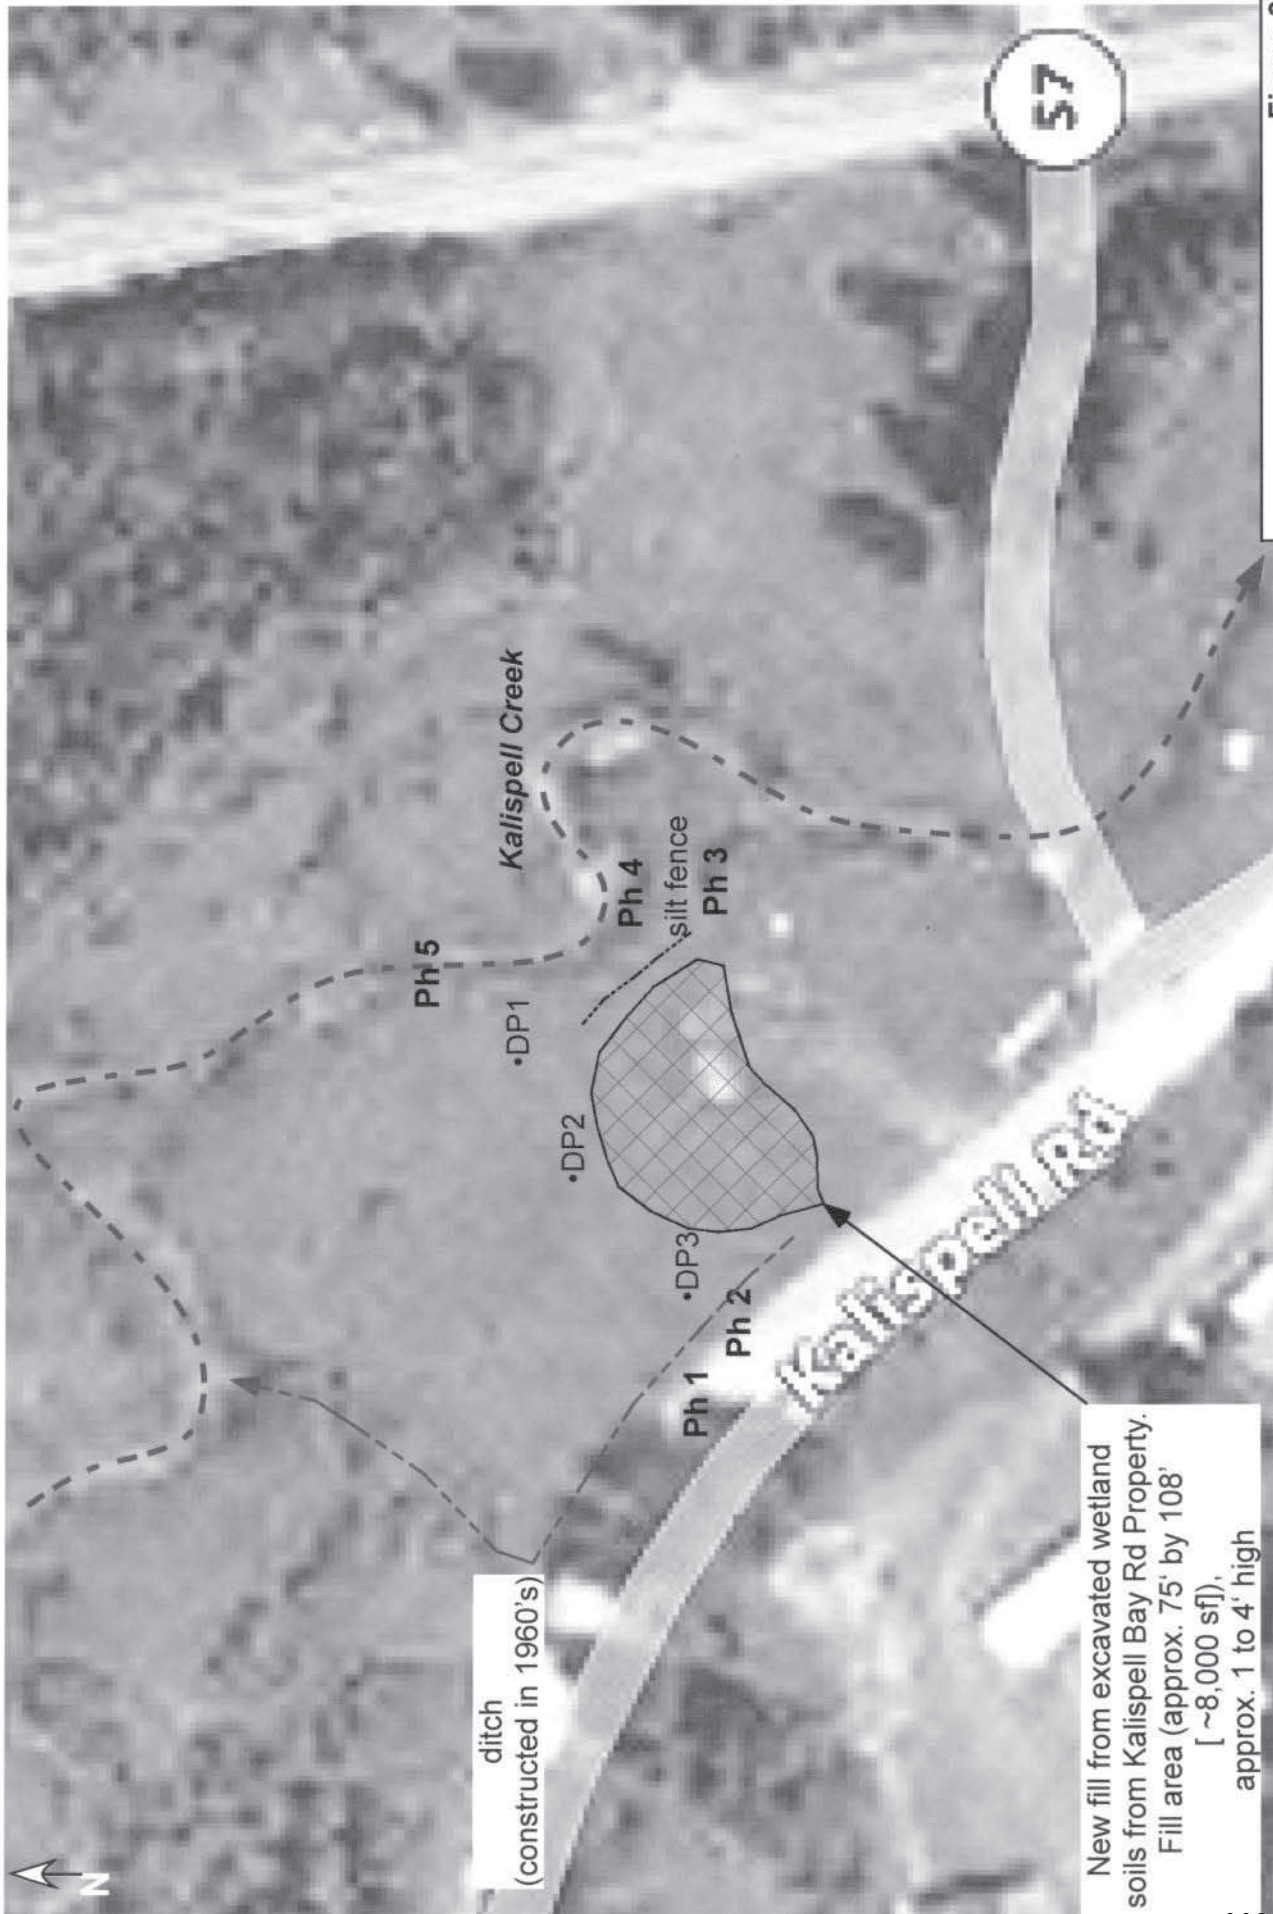
Figure 3.
 Aerial photograph, Fill area,
 Data Plot and Photograph Locations
 Sudnikovich Property
 Sackett "dumpsite"

Hydrology (free water or even moist soils) were not noted in any of the soil pits. There was one small (20' by 25') area near the southwest edge of the filled material that appeared to have evidence of short-term early spring ponding (at Data Plot 3; see Figure 3 and the Photographs). Otherwise I did not see any indication of surface ponding near the edge of fill out to more than 75 feet from the edge of fill. It appears extremely unlikely that high flows from Kalispell Creek would enter and saturate the bench area: it does not appear to be an active floodplain.

ditch
 (constructed in 1960's)

New fill from excavated wetland
 soils from Kalispell Bay Rd Property.
 Fill area (approx. 75' by 108'
 [~8,000 sfl),
 approx. 1 to 4' high

Data Plot detail in Data Sheets
 Photographs shown and described in Photosheet
 Fill is largely wetland mucky soil, moved here because of unsuitability
 for use at proposed building pad on Kalispell Creek Rd site

Based on the three data plots and time spent walking the entire area surrounding the recently placed material, it is my professional opinion that except for a very small (2' wide by 10' long) area of the upper terminus of the roadside ditch, the fill was not placed on a wetland, and the immediately surrounding area (out to about 75 feet or more from the edge of fill to the west) would not be considered jurisdictional wetland per the 1987 Corps Wetland Delineation Manual. The north edge of the recently placed material lies about 23 feet from the top-of-bank of Kalispell Creek where I would draw the wetland/upland boundary in that area.

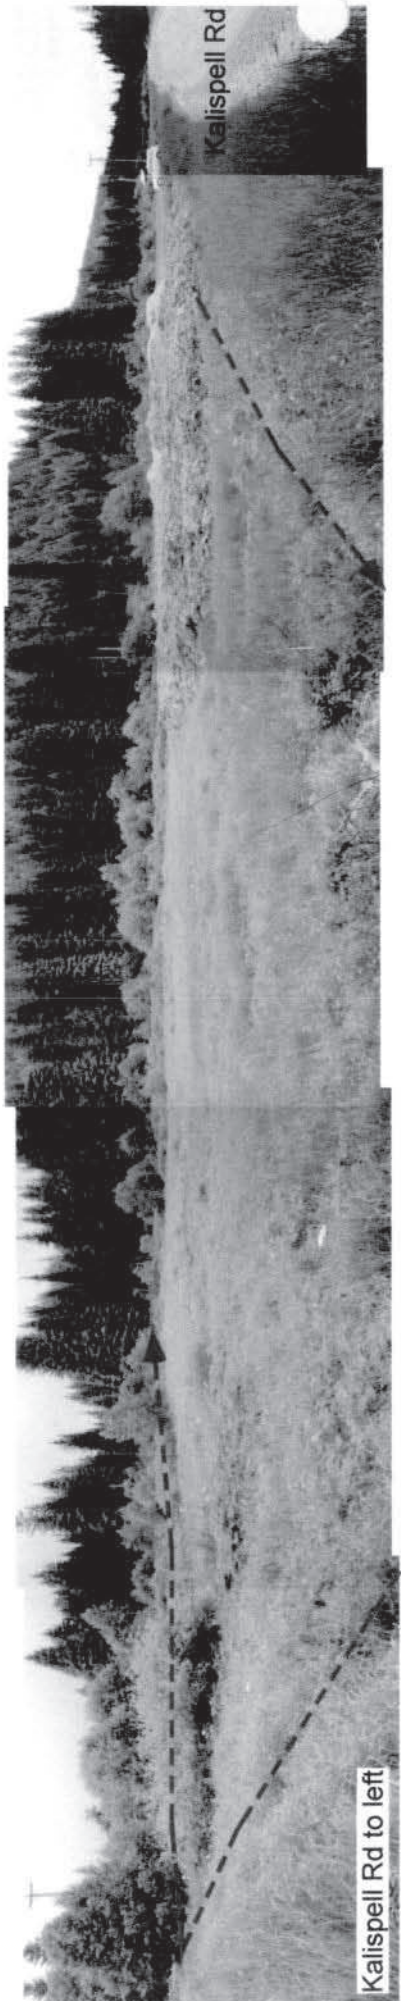
Vegetation in the relatively flat bench consists primarily of quackgrass (FAC-), tansy (NI), Kentucky bluegrass (FAC), Canada thistle (FACU), with lesser amounts of patchy canarygrass (FACW) nearer the north-trending ditch, and scattered patches of *Carex microptera* (FAC), red fescue (FAC), and cow parsnip (FAC). Overall, the vegetation is not hydrophytic though some small areas are dominated by FAC species.

Photo-montage 1: View west -> north -> east from Kalispell Rd. View across "meadow". Dominant vegetation is quackgrass and tansy, with lesser amounts or thistle, bluegrass, and canarygrass. Blue lines are ditches excavated (probably) in mid-1960's when original area was filled (by ITD) as main road was moved east to present location.

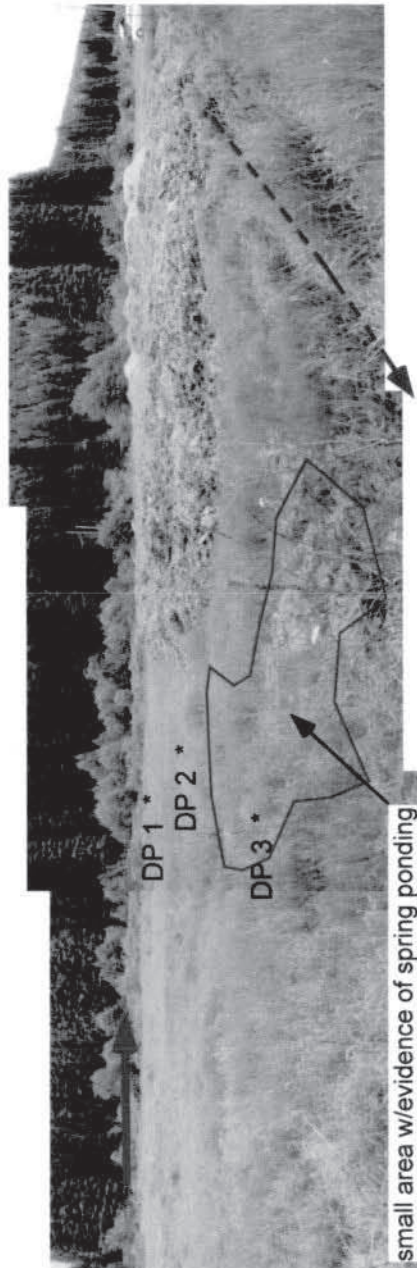
Photo-montage 2: View north from Kalispell Rd. View across "meadow". Kalispell Creek in background at red arrow (spiraea and willows). Dominant vegetation in meadow is quackgrass and tansy, with lesser amounts of thistle, bluegrass, and canarygrass. Closed blue line indicates only area noted with some evidence of short-term seasonal ponding (possibly to 6"?). Vegetation at Data Plot 3 is quackgrass and tansy. Soils were 10YR 3/2 to a sand layer at 16". Very slight to no mottling.

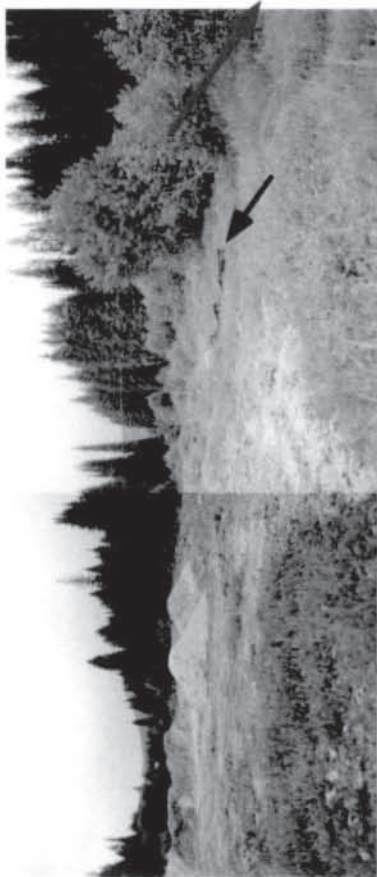
A short length of silt fence was placed approximately 8 feet from the top-of-bank of Kalispell Creek near the northern edge of the fill. The fill is about 15 feet back from the silt fence. The area of fill is roughly 75 feet by 108 feet (ca. 8,100 square feet in extent) and ranges from 1 foot to about 4 feet higher than the surrounding ground.

Photomontage #3: View from north end of fill, view west. Creek at right (red arrow). Silt fence at black arrow. Silt fence is 15' north of edge of fill. Top-of-bank of creek is 8' north of silt fence. Wetland edge is at top-of-bank.

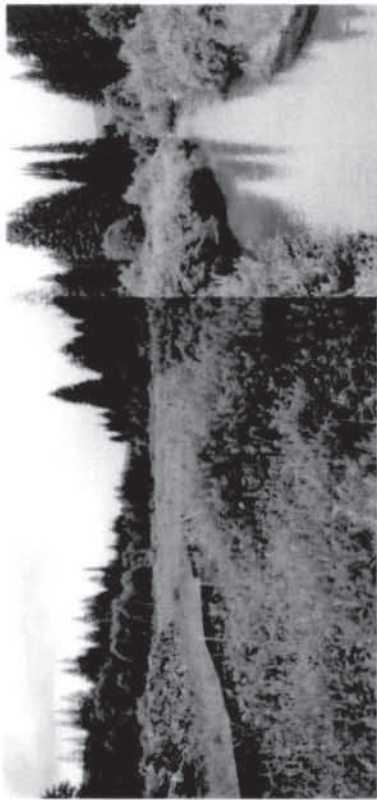
Photomontage #4: View west from creek near top-of-bank of creek. Comments as in Photo #3. Only vegetation at top-of-bank is wetland.

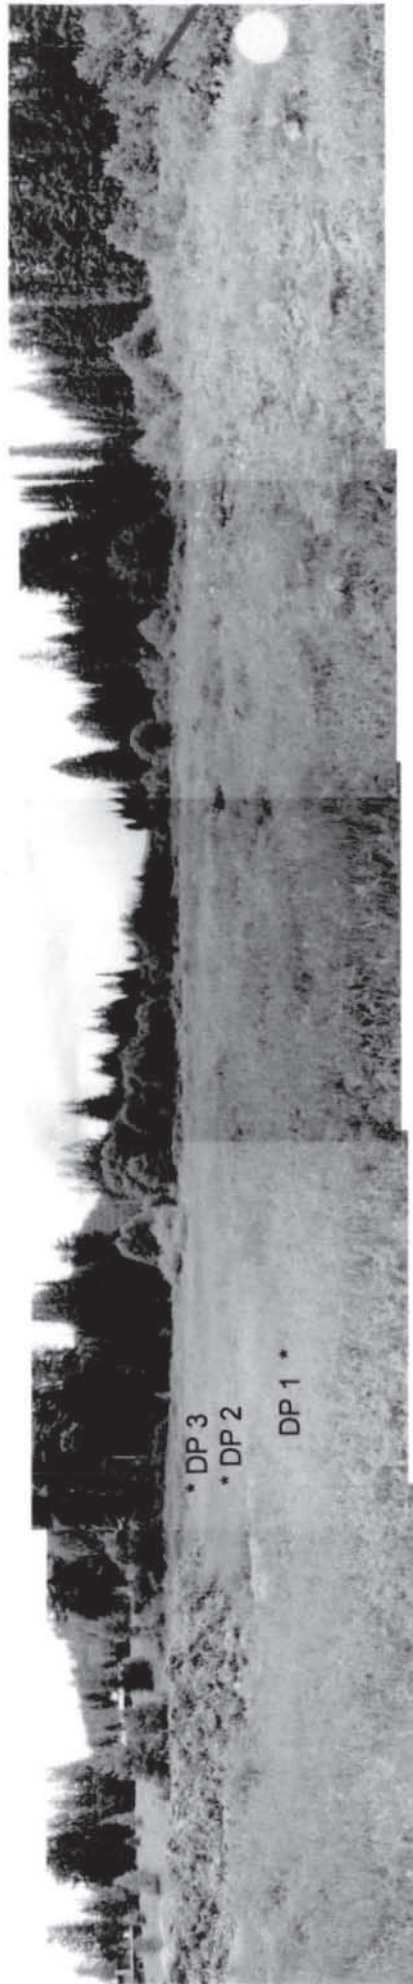
Photomontage #5: View from northwest end of fill, view south and west. Creek at right (red arrow). Data Plots shown. This vegetation is disturbed, heavy tansy and quackgrass; few cow parsnip, and (possibly) remnant sedge (less than 3% overall in "meadow"). Other grasses include Kentucky bluegrass, orchardgrass, canarygrass (few patches) and fescue. Overall, the vegetation is not hydrophytic, though some hydrophytes are present in small cover amounts. Soils at the Data Plots all similar - 10YR 3/2 with few, fine, faint mottling (7.5YR 4/4) with a sand layer at 9" (DP 1), 14" (DP 2); and 16" (DP 3). No strong hydrology indicators, nor was there evidence of ponding in majority of meadow. No hydrology in soils, nor were the soils moist at 16".
