Telephone conversation, May 14, 2008

USFS has a 1932 aerial photograph of the Sackett site and surrounding area. No roads or houses are visible in the area at the time of the photo. Jill stated that the wetland area appeared to be continuous to Priest Lake with possibly a trail along the lake shore. The wetland area appeared to narrow a bit close to the lake. Jill viewed the photograph stereoscopically and found the area appears very flat throughout the wetland area.

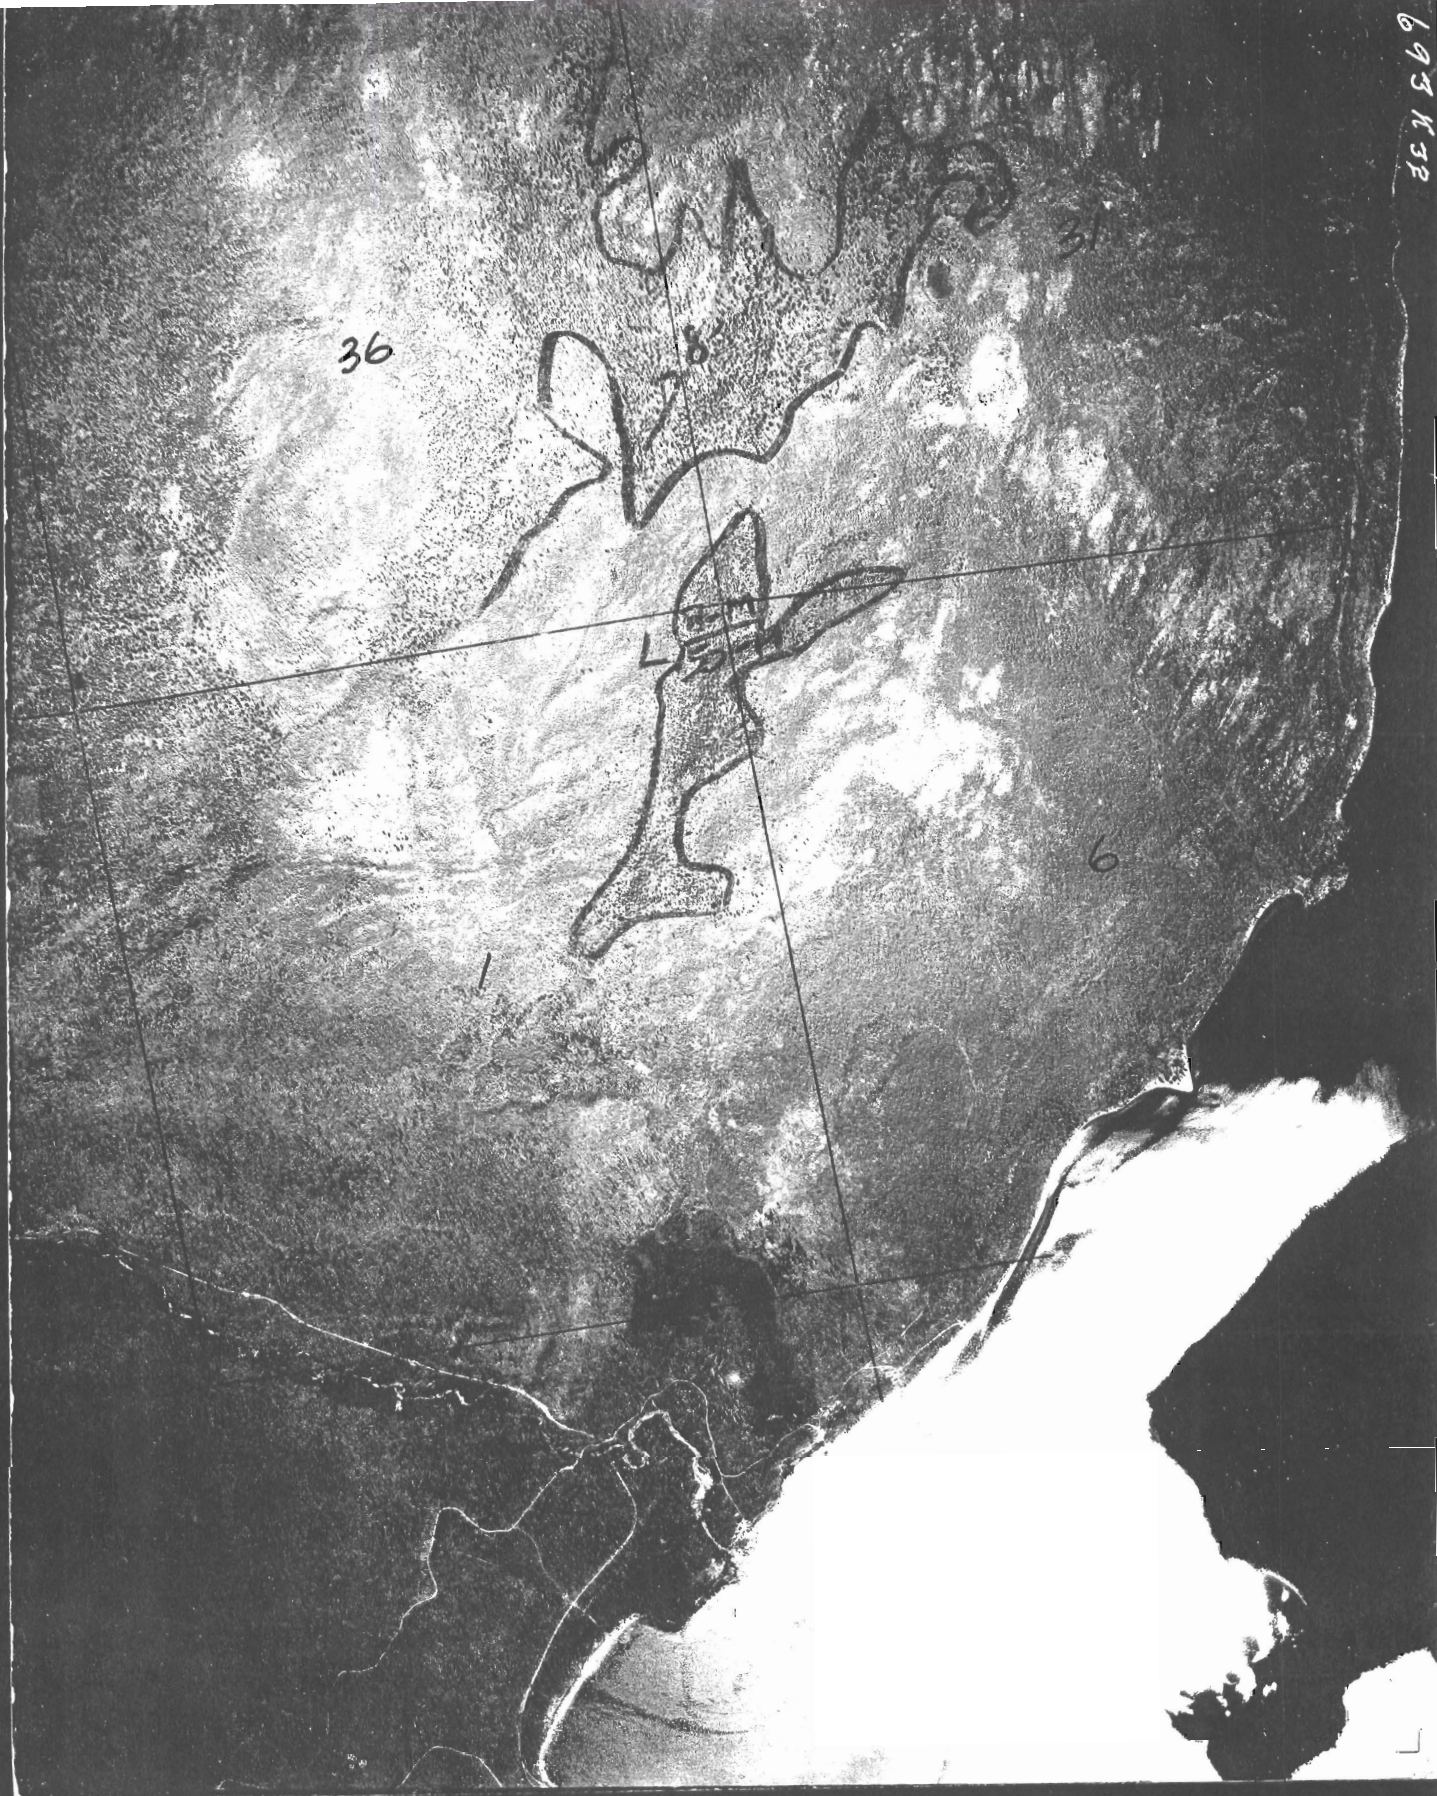
693 N 32

Here are the two 1932 photos. The point jutting into the lake is Indian Rock.

You can clearly see the wetland and a couple of older trails. I think the wetland almost reached the lake & probably had either a short single thread channel leading into it or met the

lake.
